ADAPTIVE REUSE GUIDELINES ON WARENHUIS MEDAN AND URBAN HERITAGE ENVIRONMENT

Denny Winata¹, Rumiati Rosaline Tobing², Rahadhian Prajudi Herwindo³
(1)(2)(3)Department of Architecture, Faculty of Engineering, Universitas Katolik Parahyangan, Bandung, Indonesia
¹ddennywinata@gmail.com, ²rumi@unpar.ac.id, ³dodo@unpar.ac.id

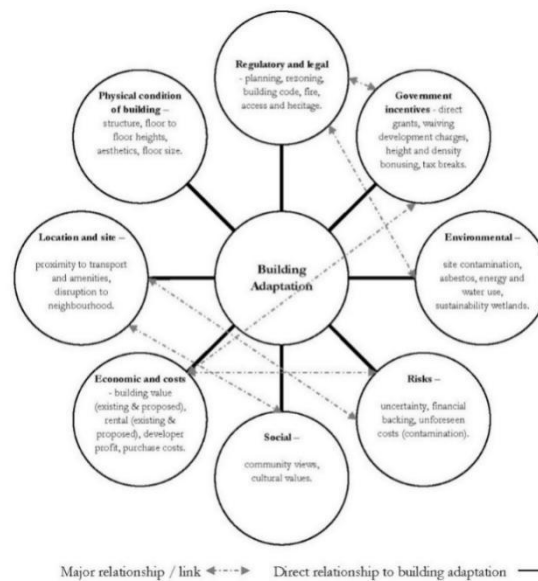
Figure 1. Factors related in building adaptation

Theoretical reference in this study is based on building adaptation theory (Wilkinson, 2011) , which elaborates 8 factors in building adaptation: (1) regulatory and legal, (2) government incentives, (3) environmental, (4) risks, (5) social, (6) economic and costs, (7) location and site, and (8) physical condition of building. These factors have multiple relationship with one another that relates to internal and external aspects of a revitalizing historic building.

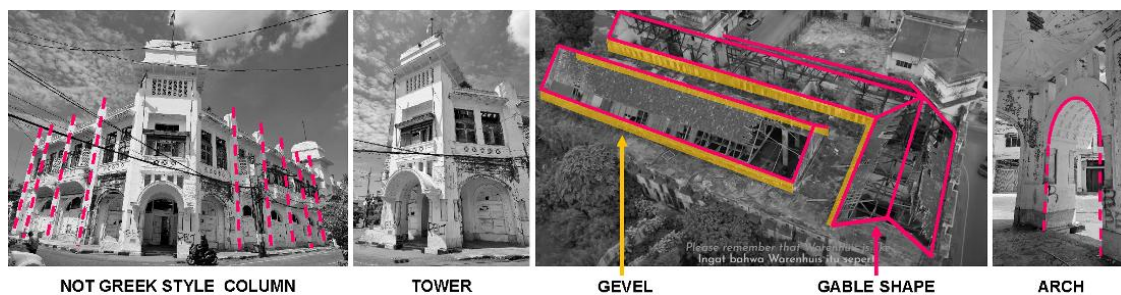
- a. symmetrical layout with open space in the centre and terraces along its perimeter,
- b. Greek style column are not found on its elevation,
- c. possess unique building elements, like tower on entrance and gevel on roof,
- d. building construction system uses concrete structure and arch profile,
- e. roof structure, door, and window uses wood material, and
- f. its roof uses gable shape with clay tile as roof covering material.

Figure 5. Characteristics of transitional colonial style in Warenhuis architecture

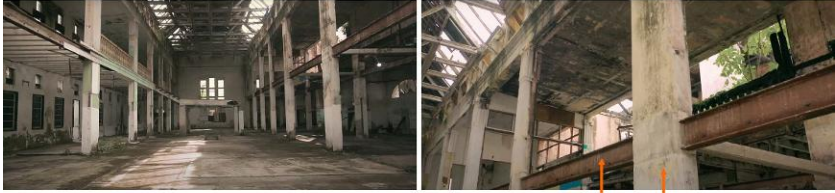
<p style="text-align: center;">Rust on steel beam Moss on concrete column</p>	
	<p style="text-align: center;">Figure 6. Column and beam structure</p>	
	From external observation, the concrete column are in good condition, while beam uses steel I-beam 200. Structure strength after the fire incident cannot be confirmed as it requires forensic engineering to further analyse its building strength.	Moss can be found on concrete column, while rust can be found on steel beam.
2	Roof structure and covering

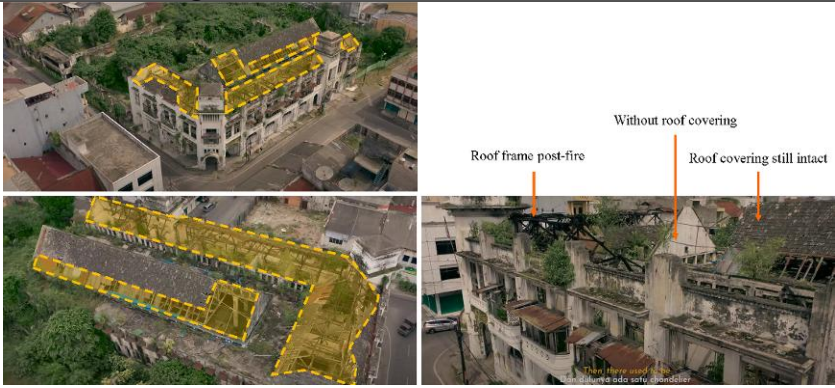
<p style="text-align: center;">Without roof covering Roof frame post-fire Roof covering still intact</p>	
	<p style="text-align: center;">Figure 7. Roof structure and covering</p>	
	Indications of fire can be seen from the condition of damaged wooden frame and its black colour from carbon residue.	Roof covering layer of clay tile has been partially destroyed while the remaining are still attached, however, their quality needs to be examined.

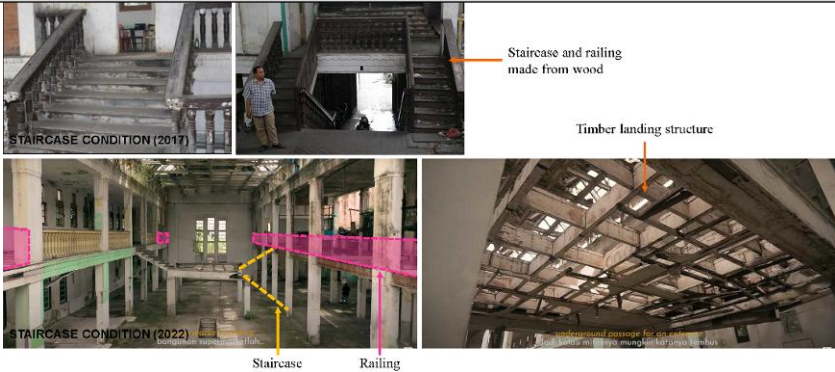
<p style="text-align: center;">Staircase and railing made from wood Timber landing structure Staircase Railing</p>	
	<p style="text-align: center;">Figure 8. Main staircase and railing</p>	
	Structure: It is made of wooden structures. Their condition has been mostly damaged, leaving	Timber on thread and riser has been non-existent.

some of landing frame and steps on the upper section of staircase.

There are only small portion of railing left on mezzanine.

The remaining railings are still in good condition that replication can follow the existing details.

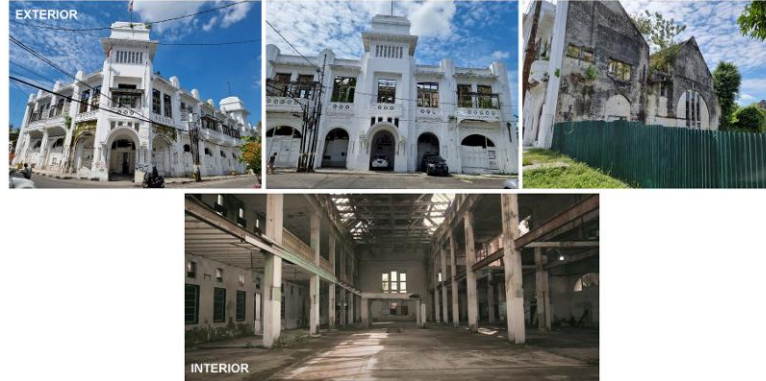
Figure 9. Exterior and interior of Warehouse

External and internal walls area made of bricks.

The white paintwork has faded and covered in moss. The exterior walls are covered heavily in moss because they are exposed on sun and rain.

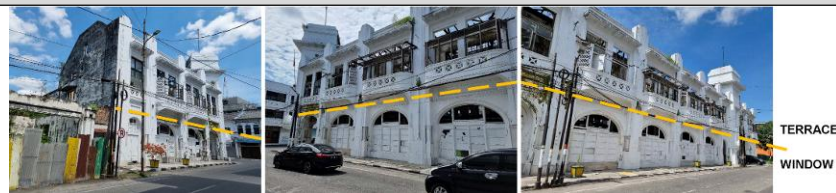
Figure 11. Terrace and window on Warehouse

Material on terrace are brick and ventilation block. Some of the window frame and roof covering have been destroyed.

Moss grows on brick walls and ventilation block. The paint on the walls, ventilation block, and window frames have faded.

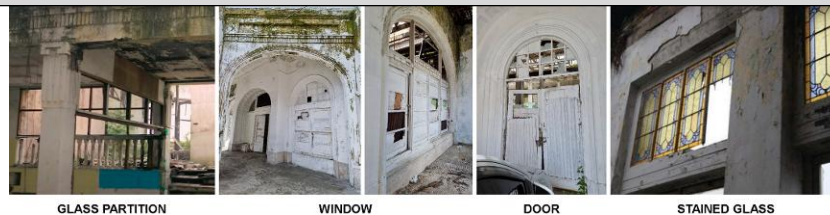
Figure 12. Interior partition and façade of Warehouse

Internal partition frames and windows on facades are made of wood. Some of the frames are still standing, but others are badly damaged. The strength and durability of the frame structure need to be further examined.

Paint on the wood frame is faded, while stained glass covering has been damaged.

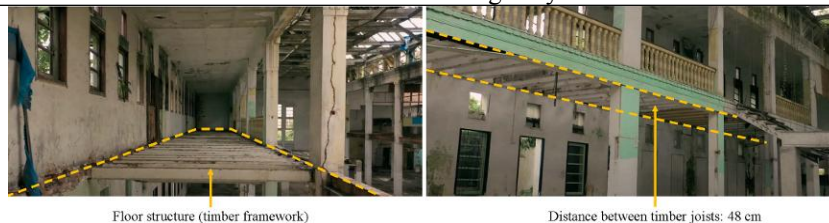
Figure 14. Floor framework on mezzanine level

The floor uses steel structure as the main beam and a wooden structure as the joist. Distance between beams is 48cm.

Mezzanine floor is covered with wooden planks which currently cannot be found in the building.

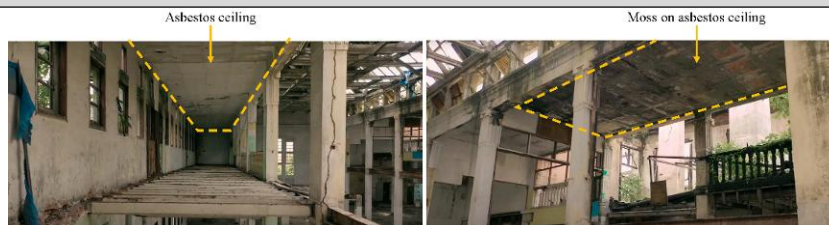
Figure 15. Asbestos ceiling on Warenhuis building

Most of the building frames cannot be found. The existence of ceiling only remains on the mezzanine floor, while first floor ceiling and the rest of mezzanine floor cannot be found.

Most of ceilings used in this building are asbestos based materials. Moss can be found on the remaining asbestos ceilings.

6. Adding new building elements must be compatible with the air circulation.
7. Hazardous materials, such as asbestos need to be replaced.

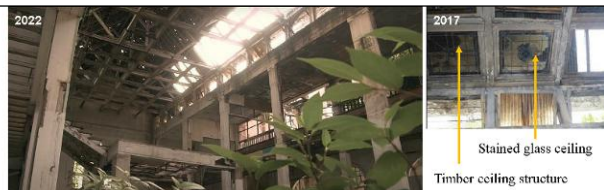
Figure 16. Stained glass ceiling at the atrium

Ceiling in the atrium uses a special stained glass material with a wooden frame. The wooden frame is still attached to the building but its structural strength needs to be further reviewed through forensic engineering.

Stained glass on atrium ceiling has been completely damaged.

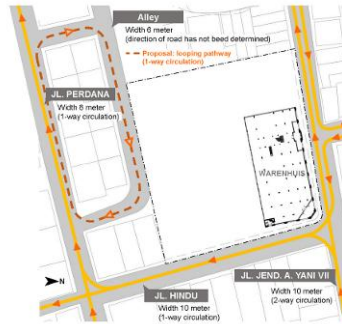
Figure 18. Existing and proposed circulation around Warenhuis

4	Green zone in the city centre	Green open space and urban greening are currently only at open fields like Merdeka, Benteng, and along Deli River
5	Road circulation around Warenhuis	Traffic volume is high, but the main road only has 6-10 meter width

6	Parking facility	Only 1 parking lane (combine with pedestrian walkway) which is not ideal
---	------------------	--

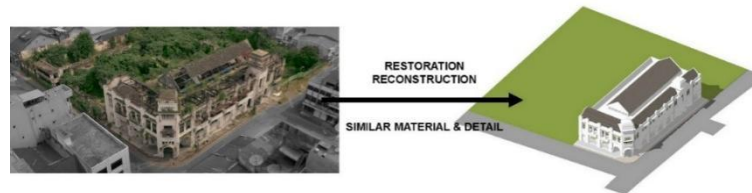
Figure 26. Revitalization of Warenahuis through restoration and reconstruction.

1. The restoration and reconstruction process must adopt similar architectural detail and material as the original.

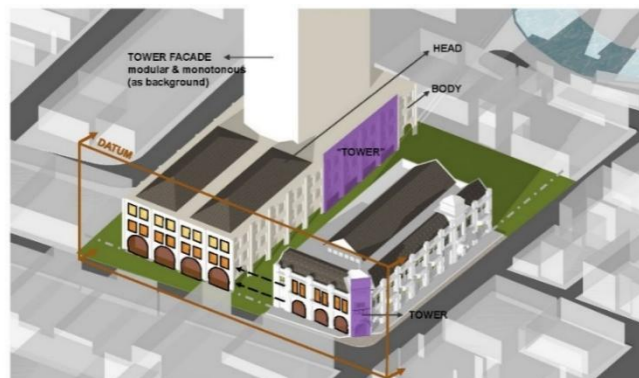
Figure 34. Datum on architecture façade.

10. The architectural datum of Warenhuis and the neighbouring development must apply similar façade composition in scale, shape, repetition, and hierarchy (tower).
11. Use of local material to support energy efficiency in construction.
12. Material and building ornaments of Warenhuis can be an inspiration to contemporary interpretations.
